Manhole Inspection Summary

Manhole # S29SS_071MH

Location Address: **701 FALLS RD**

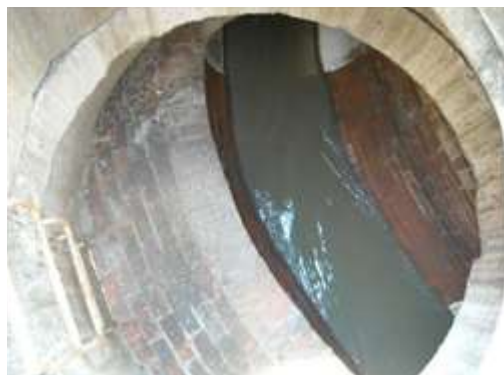
Top View

Bench debris.

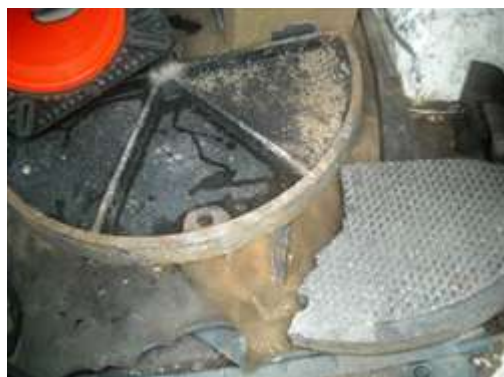
MISC.

BROKE CRACKED LID

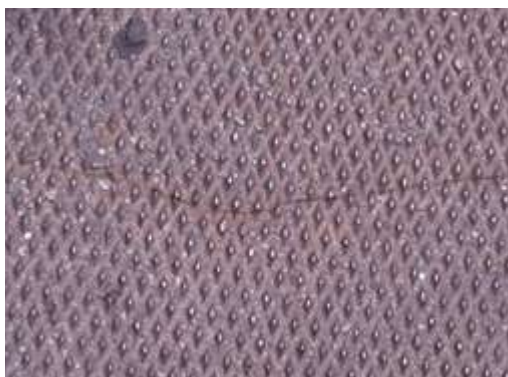
Defect

Type: **Sanitary** Condition: **Cracked** Cover Material: **Cast Iron**

Cracked cover.

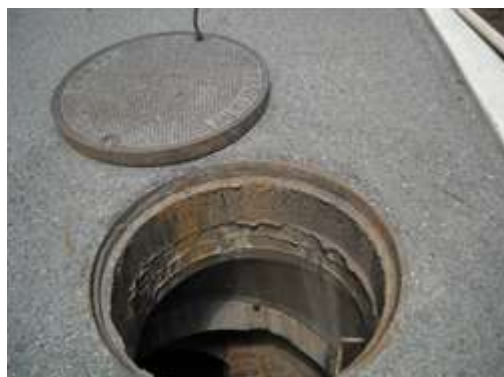
Defect

Frame Offset: **0** (in.) Condition: ☐ Sound ☐ Cracked ☒ **Leaks**

Infiltration: ☐ None ☒ **Joint** ☐ Cracks ☒ **Mortar** ☐ Roots ☐ Wall

Infiltration: ☐ None ☒ **Joint** ☐ Cracks ☐ Mortar ☐ Roots ☐ Wall

Frame leaks. Adjustment, Corbel and Barrel infiltration.

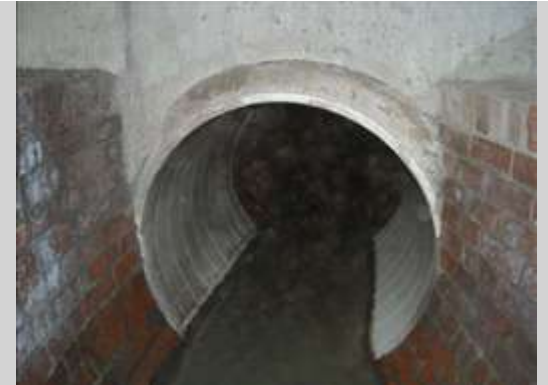
36 in. Circular Gravity Sewer Pipe Out @ 12 O'Clock

Infiltration: **Evidence** Pipe Seal Cond: **Unknown**
